Land Subsidence at Survey Mark SS3315 Half way up Rewa Rd

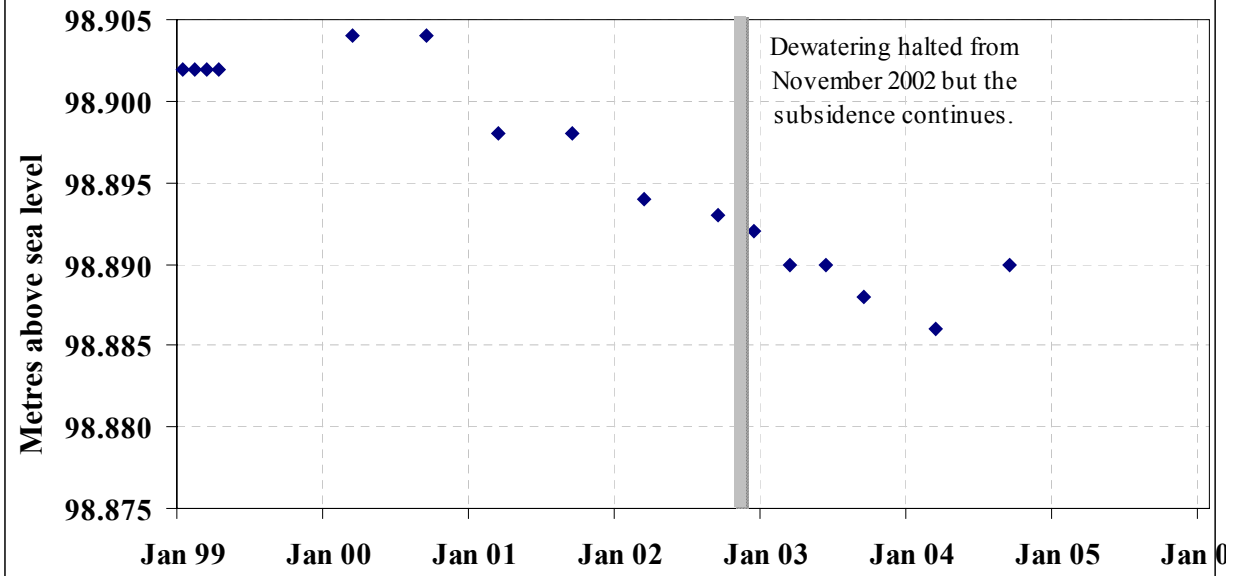
Land Subsidence at Survey Mark SS 3316 Top of Rewa Road

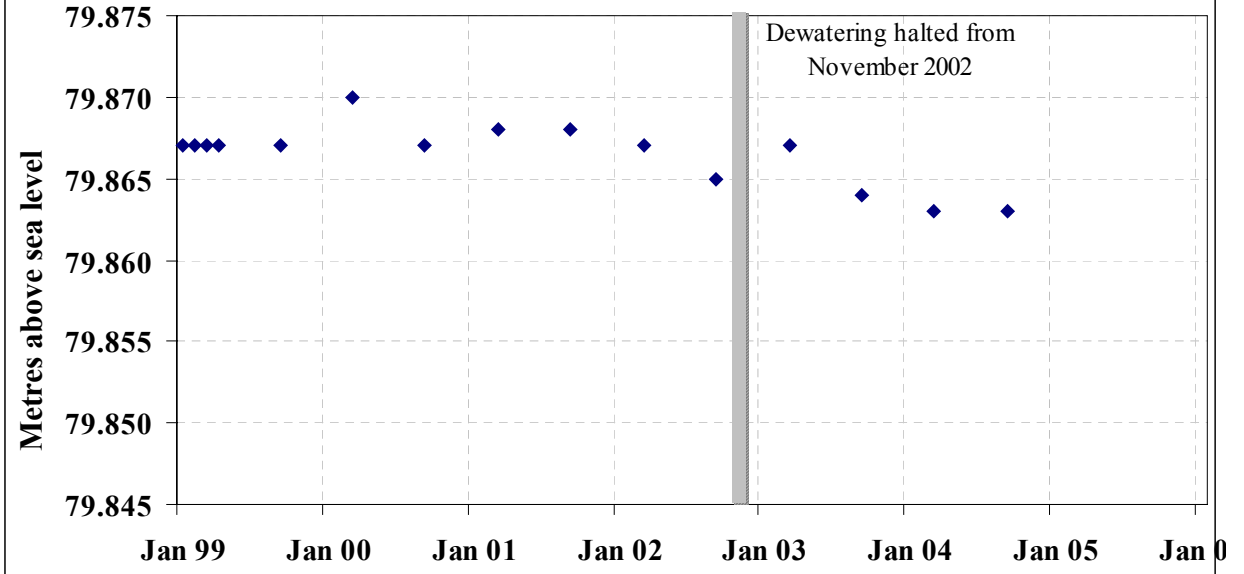
Land Subsidence at Survey Mark AP13 End of Barrister Avenue nearest the Quarry

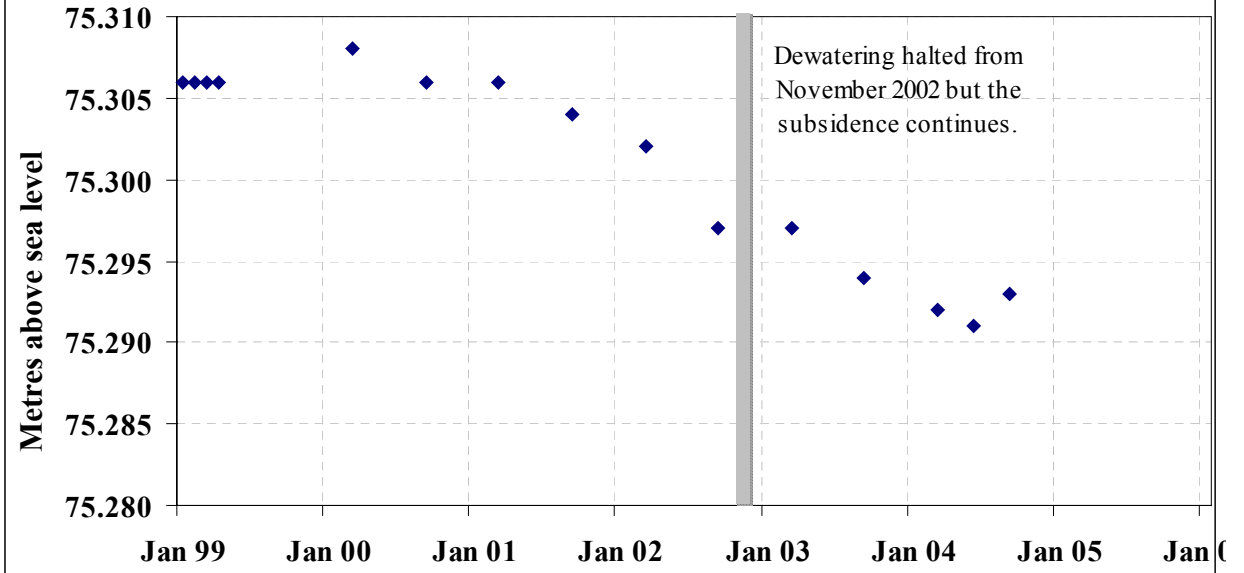
Land Subsidence at Survey Mark AP6 Near the School Gates on Queensway

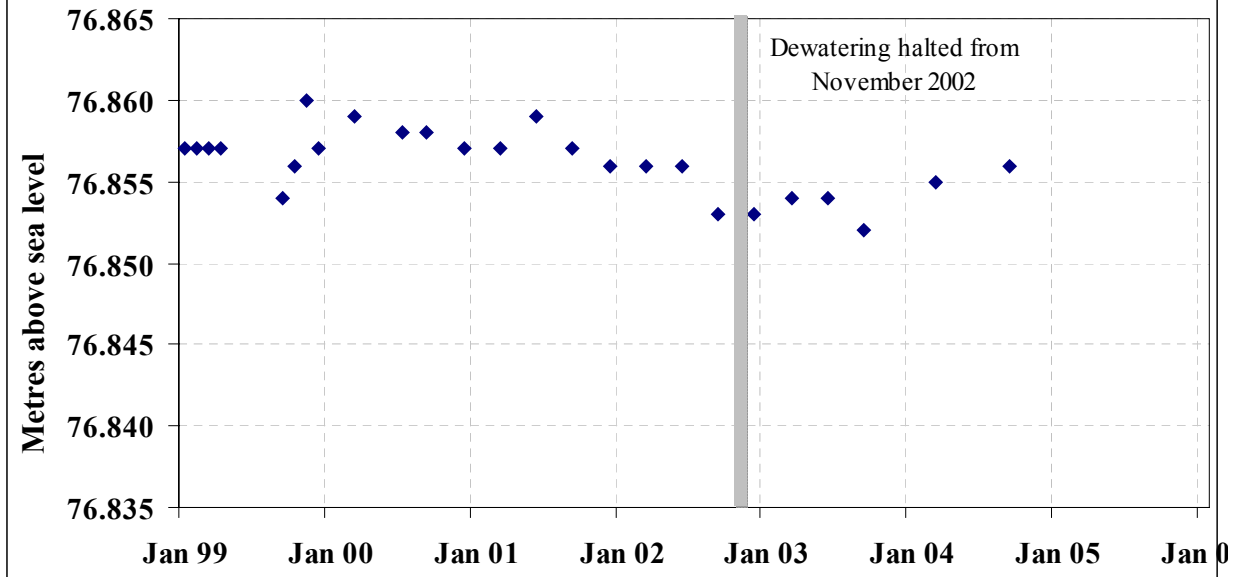
Land Subsidence at Survey Mark AP31 Near Corinne's Place

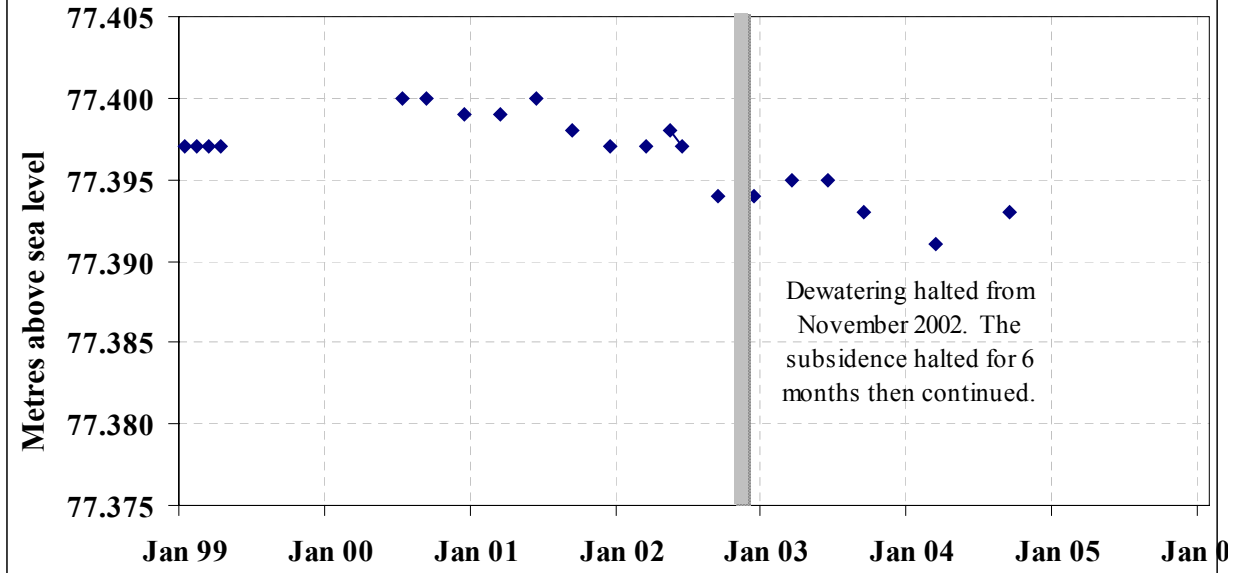
Land Subsidence at Survey Mark AP21 Corner of Kingsway and Mt Eden Rd

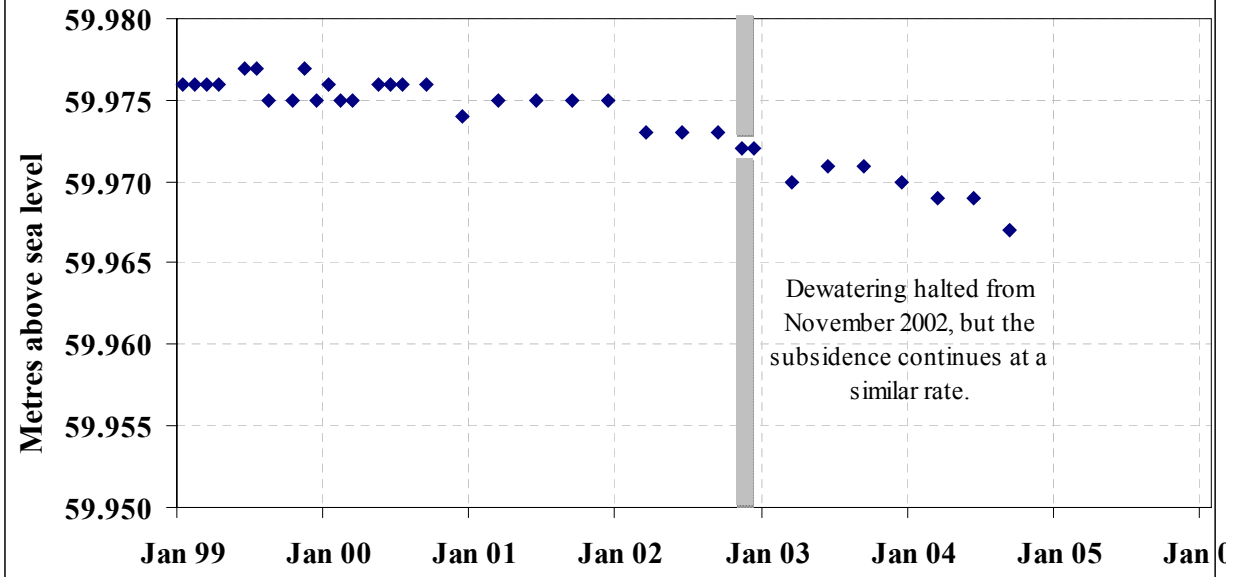
Land Subsidence at Survey Mark AP206 Corner of Mt Albert Road and Buckley Road

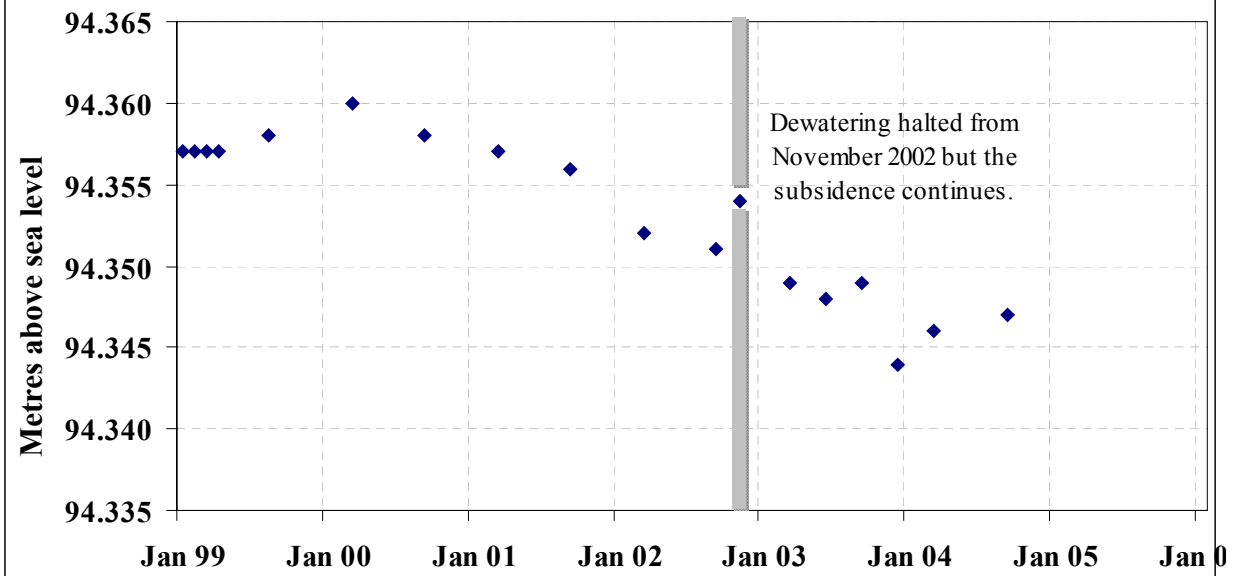
Land Subsidence at Survey Mark AP12 Peak of Warren Ave

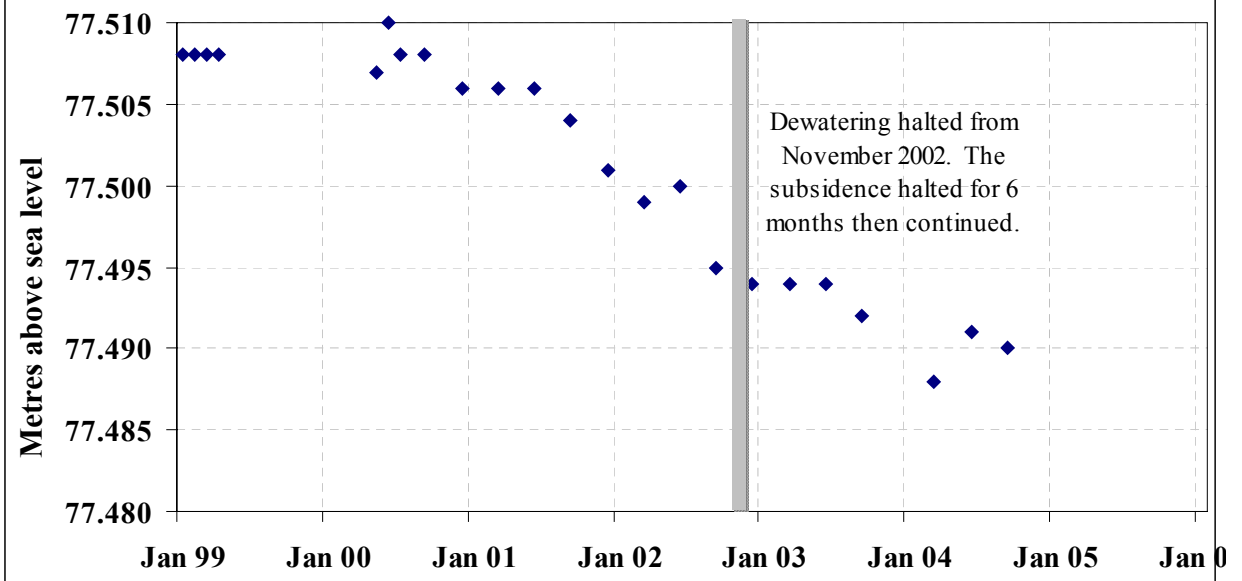
Land Subsidence at Survey Mark OAP19 St Andrews Road near the tennis courts

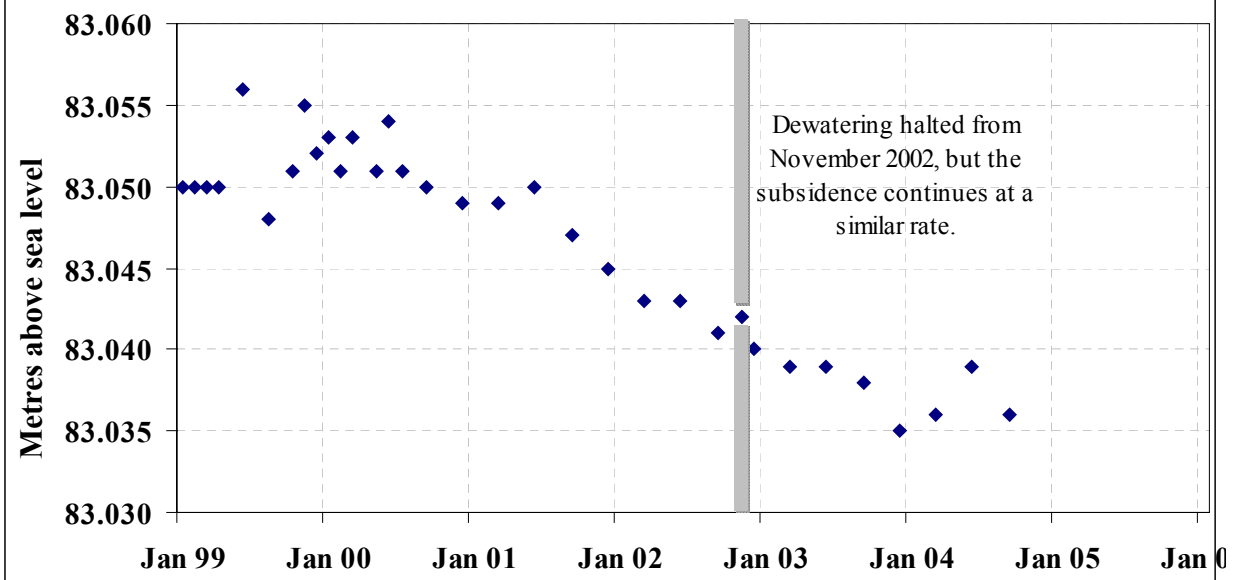
Land Subsidence at Survey Mark M210 Corner of Mt Albert Road and Warren Ave

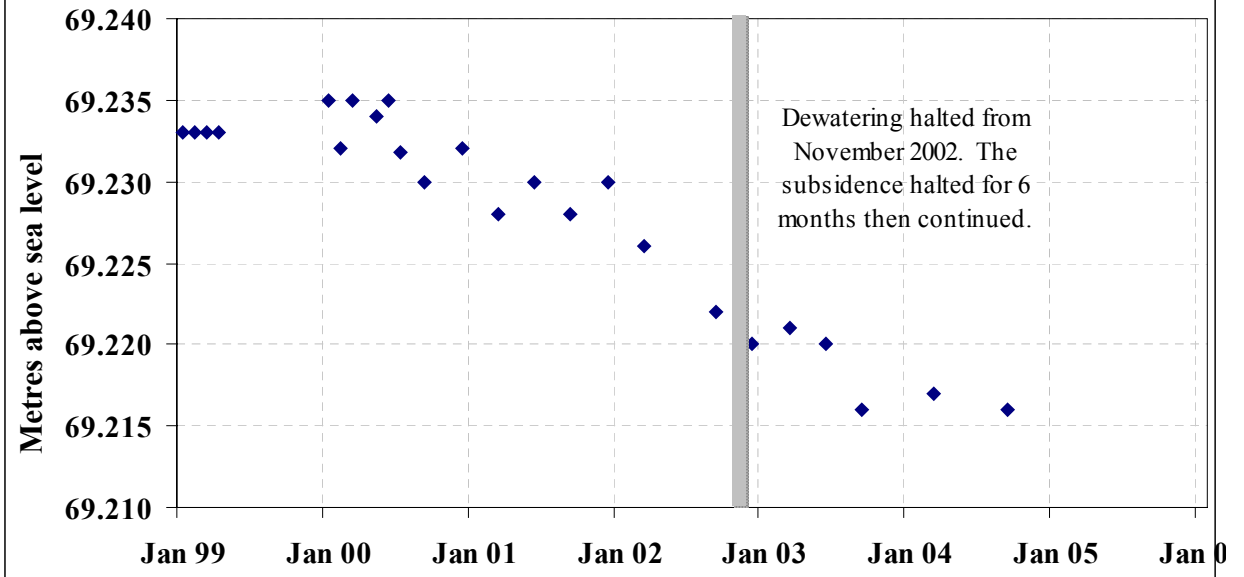
Land Subsidence at Survey Mark RM3889 Corner of Duke St and Hamon Ave

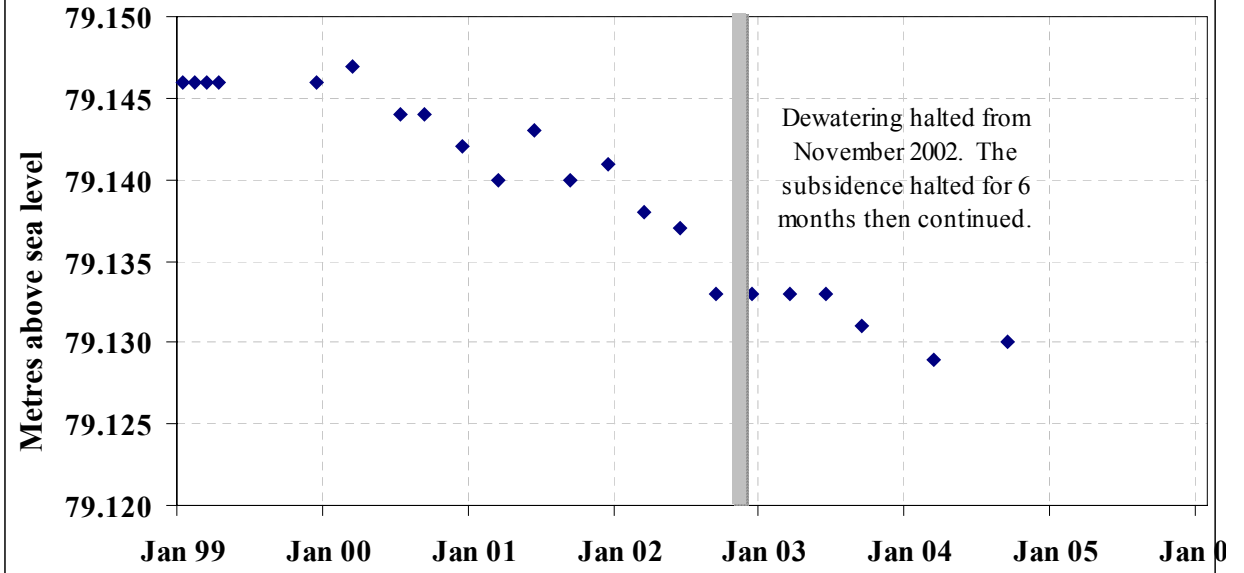
Land Subsidence at Survey Mark RM3893 Duke Street shops

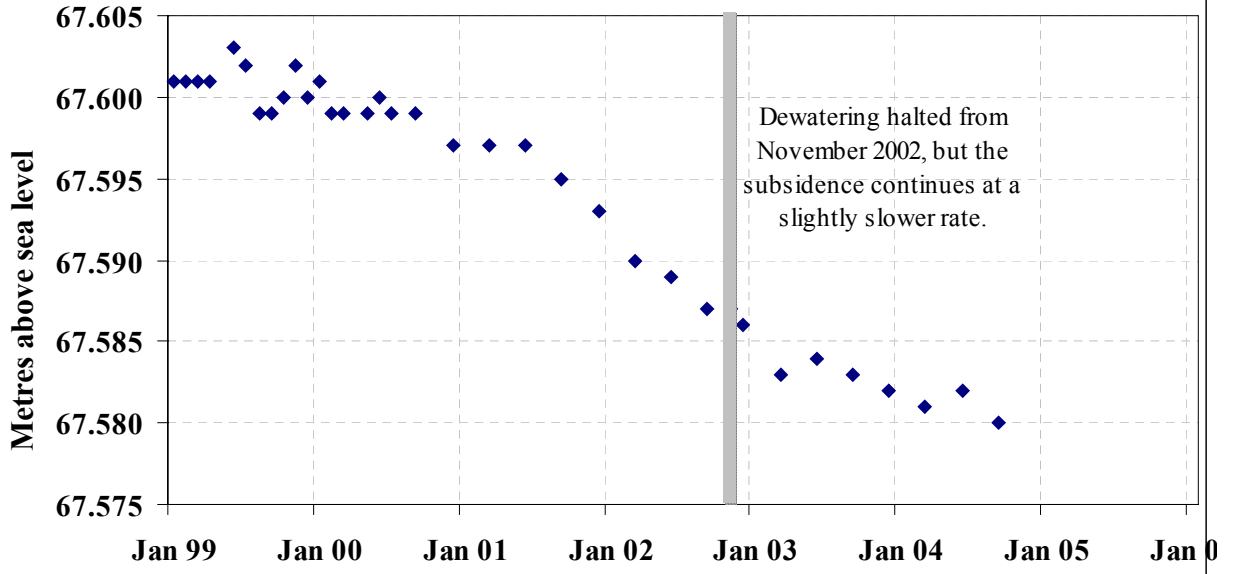
Land Subsidence at Survey Mark RM 7647 Corner of Mt Albert Road and Rowan Road

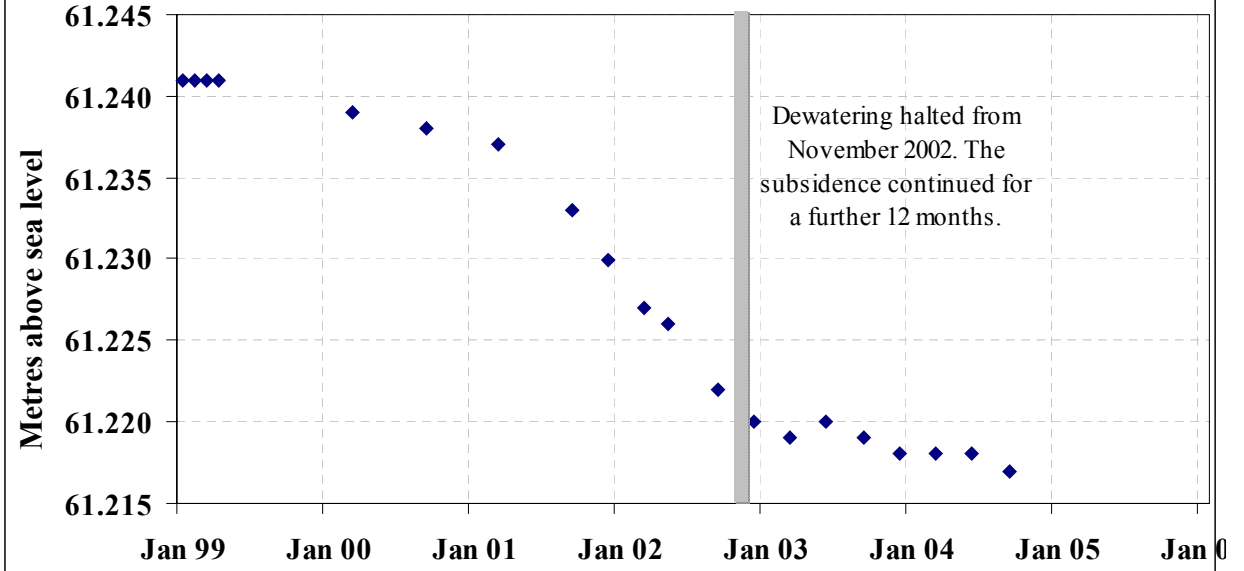
Land Subsidence at Survey Mark SM1979 On Hillsborough Road near Budock Road

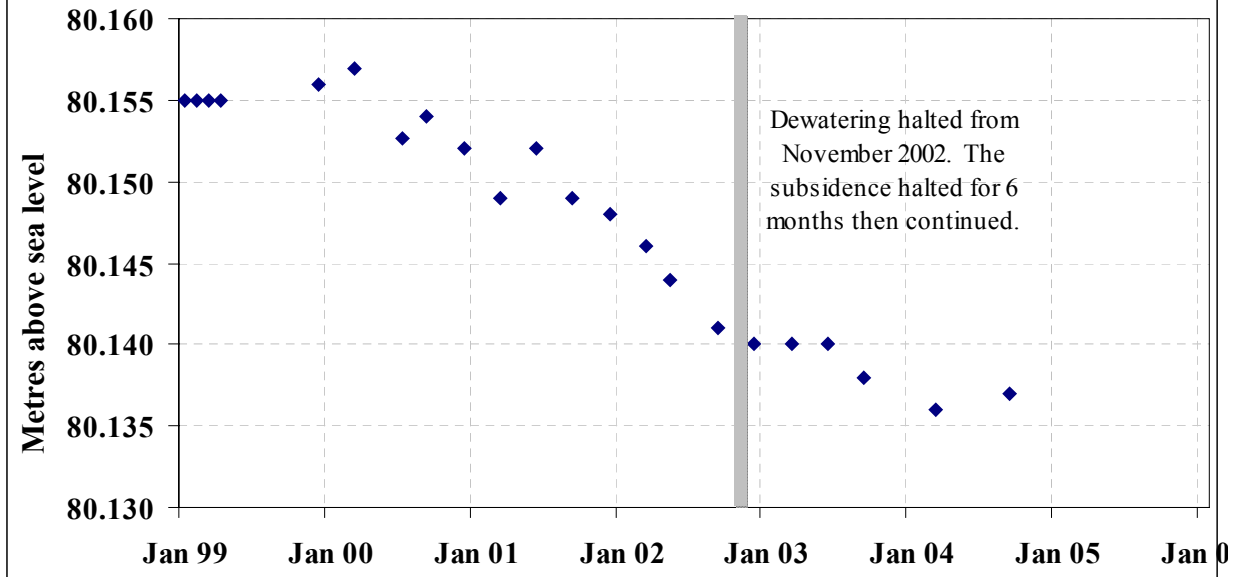
Land Subsidence at Survey Mark SM4354 Corner of Mt Eden Rd and Rewa Rd

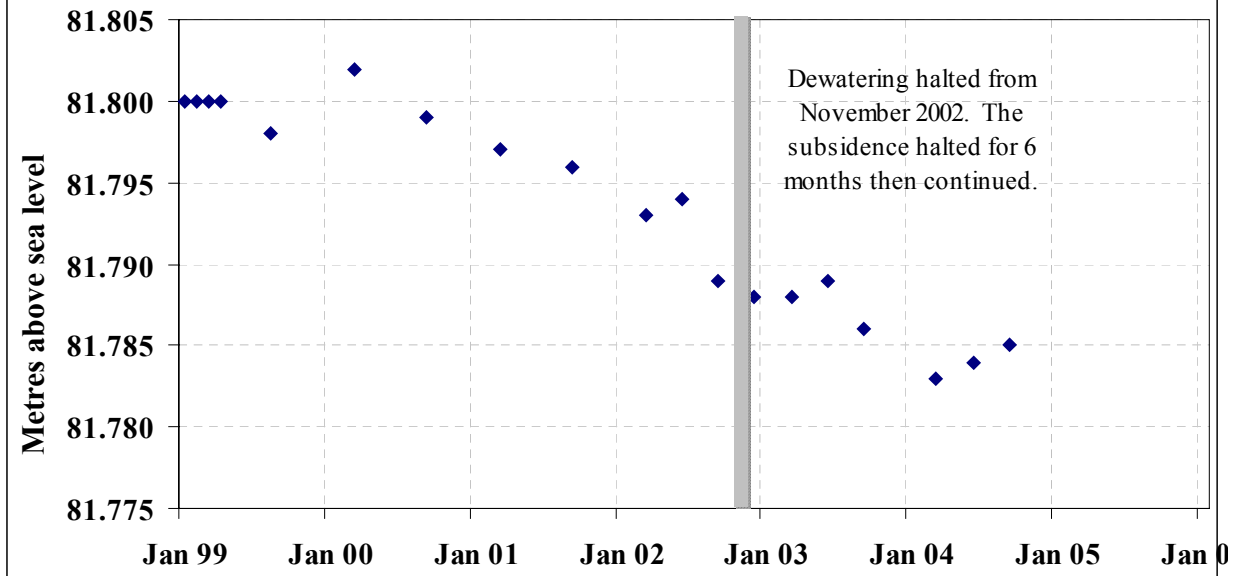
Land Subsidence at Survey Mark SM6809 Corner of Gorrie Ave and St Andrews Rd
